Scorpio Dash Vent Door(s) Fix_____

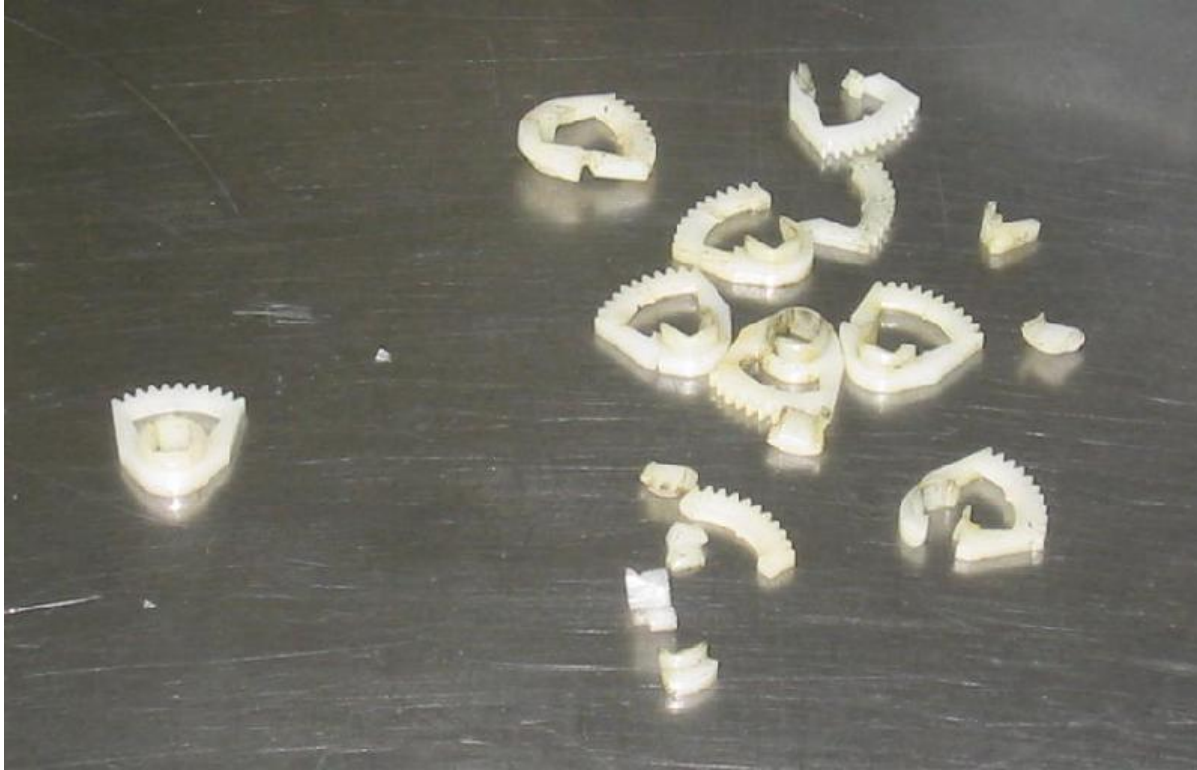
Many times the dash vent mechanisms seems to self-destruct, breaking the attaching point on the flap, and/or "hunting" for its proper position. Inside the motors for the flaps are limiter gears or cams that eventually break, letting the motors move the flap to, and past, its breaking point.

Here's the shrapnel from decaying plastic:

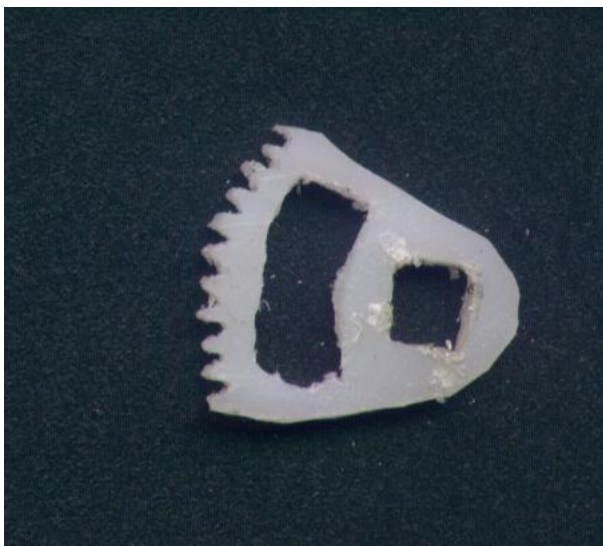
Here's approximately what the cams are supposed to look like. This gear was made from nylon stock.

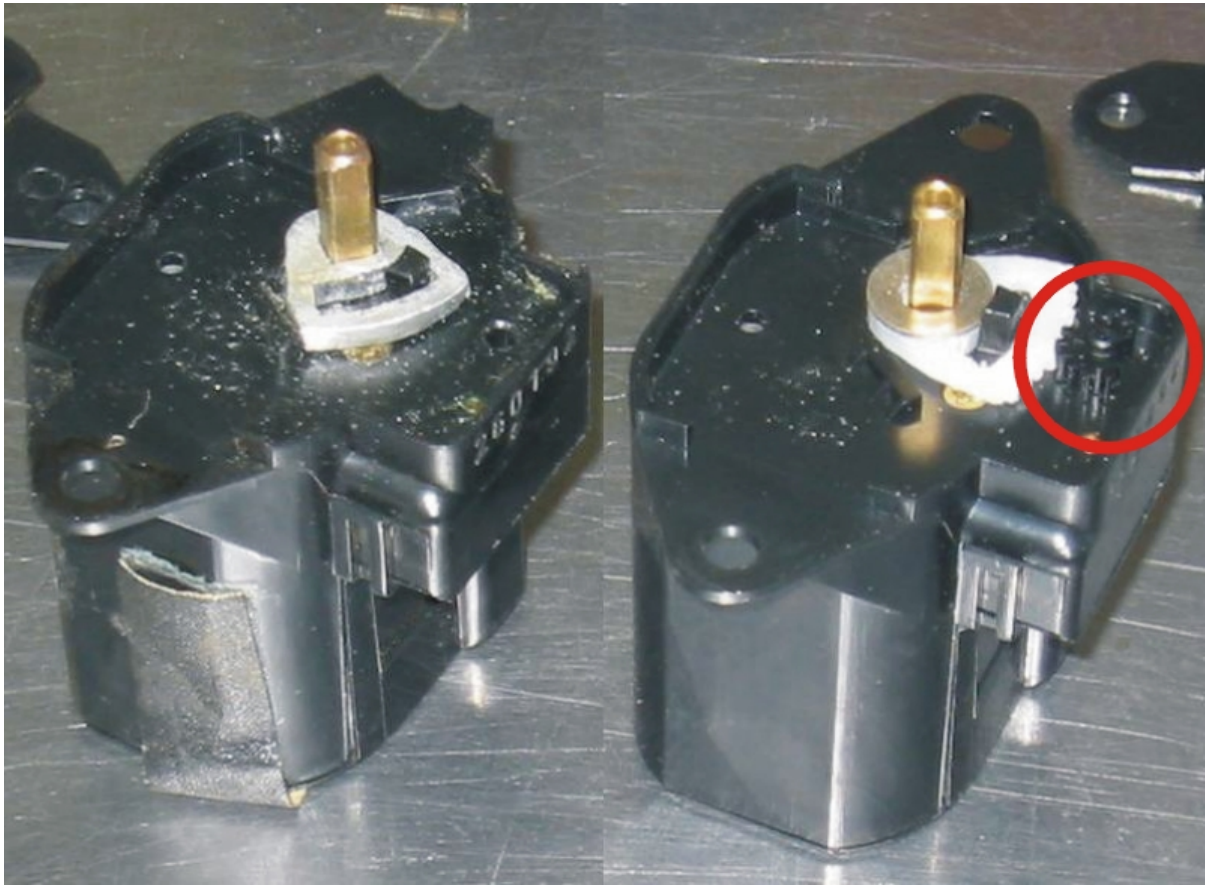
In the picture below, I made the cam on the left from a piece of aluminum. The one on the right is made from nylon. No casting material, such as Alumilite, is strong enough for the force.

The actuator on the left is for the center door; that gear is made from aluminum stock. The one on the right, made from nylon, is for the left and right doors. This one has teeth on the cam for an additional gear-driven sensor; that gear is circled in red.
